## River Erosion Impact on Transport Infrastructure in "Gilort River Nature2000 site", Romania

**Abstract:** River erosion is a complex process due to multiple factors, such as climate changes, discharge quantity, the type of transported sediments, and variations in the hydrological regime. This paper aims to analyse river erosion's impact on transport elements' stability (especially on bridges). To do so, a Geomorphic Change Detection analysis was used, which involves calculating the altitude differences between two successive digital models, as a basis for calculating surfaces and volumes of sediments displaced through the erosion process. This analysis was doubled by a series of cross-sections in the proximity of bridges to observe the current river bed configuration and identify the active processes. The variation of these processes is directly dependent on human interventions undertaken to reduce the erosion process and to protect the infrastructure elements. The bridges located in the studied area are in different stages of damage by lateral and depth erosion processes, depending on their intensity and the human interventions made to protect these bridges. The least affected

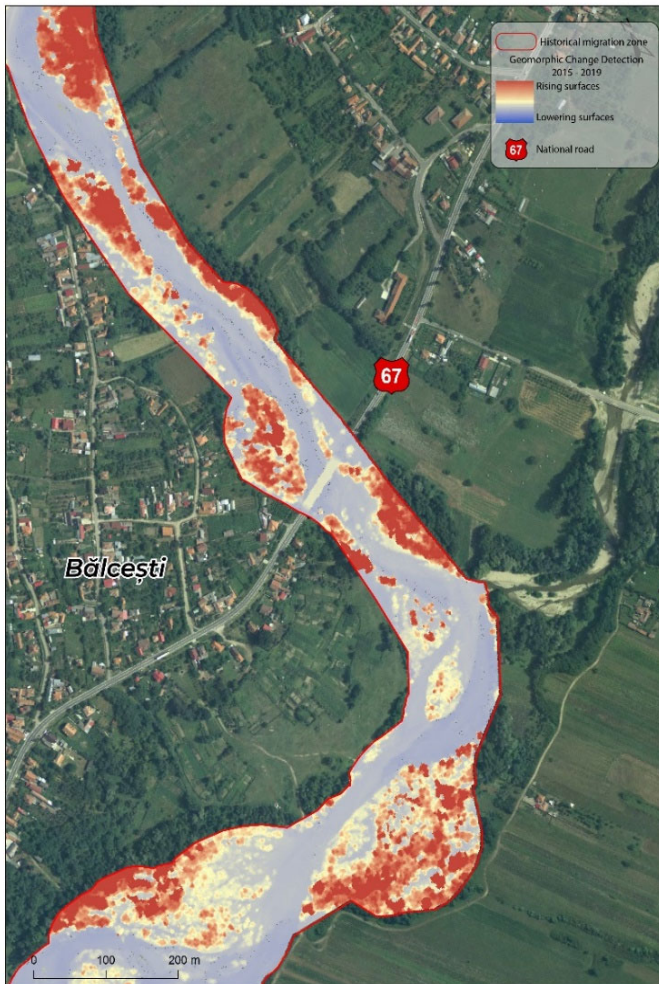
**Fig. 2.** GCD results at National Road 67

The northernmost bridge identified is the bridge on DN67 over the Gilort River in Bălcești town (Fig. 2).

This is a rehabilitated bridge for which a bed sill-type structure was built to reduce the flow speed and implicitly, the river potential energy, which reduces the erosion process at the bridge piers. As a consequence of this type of construction, according to the GCD, the topographic surface lowered less than – 0.4 m in the

time interval, compared to the areas 300 m upstream of the bridge, where the surfaces lowered by up to -1.5 m in the same period. Also, from the cross-section made immediately downstream of the bridge (Fig. 3) one can observe the asymmetric banks with a levelling of the riverbed, after which the basic elements of the bed (e.g. thalweg) can no longer be distinguished. Such an intervention (the construction of the bed sills downstream to the bridges) is the most common and with the most optimal results in terms of preserving the infrastructure elements, but it must be designed and thought to integrate into the river ecosystem so as not to create a barrier to upstream migration of fish species.

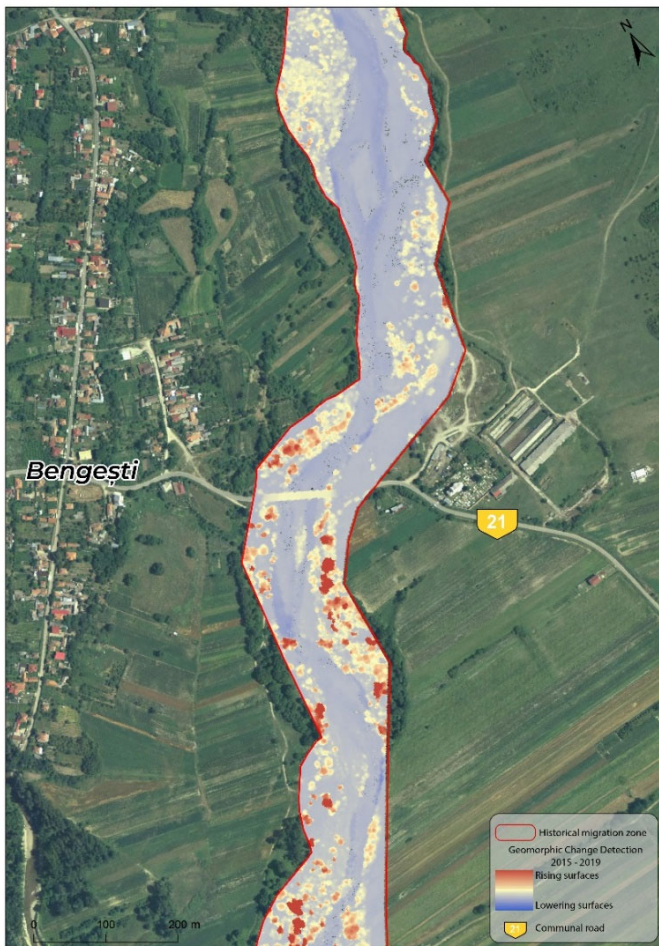
**Fig. 4.** GCD results at Communal Road 21 bridge

The second bridge is the bridge on DC21 in Bengesti town (Fig. 4). This bridge was built after 2014 when a flash flood destroyed the old bridge. This bridge has no riverbed protective structures, so it can be exposed to erosion processes at the bridge piers.

The GCD run shows that the river is divided into two arms, with a median island under the bridge. Topographic surface lowering values of up to 1 m on the eastern channel were calculated between 2015 and 2019. Also, upstream of the bridge, a sector with strong lateral erosion is identified on the left (eastern) bank, with calculated values of lowering of 3.5 m; downstream, a sector with pronounced depth erosion is identified, with calculated values of lowering of up to 3.0 m. These two sectors can contribute to the destabilisation of the bridge, by advancing lateral erosion and affecting the bridge's connection to the main road, respectively by changing the longitudinal profile of the river and advancing in depth erosion upstream.

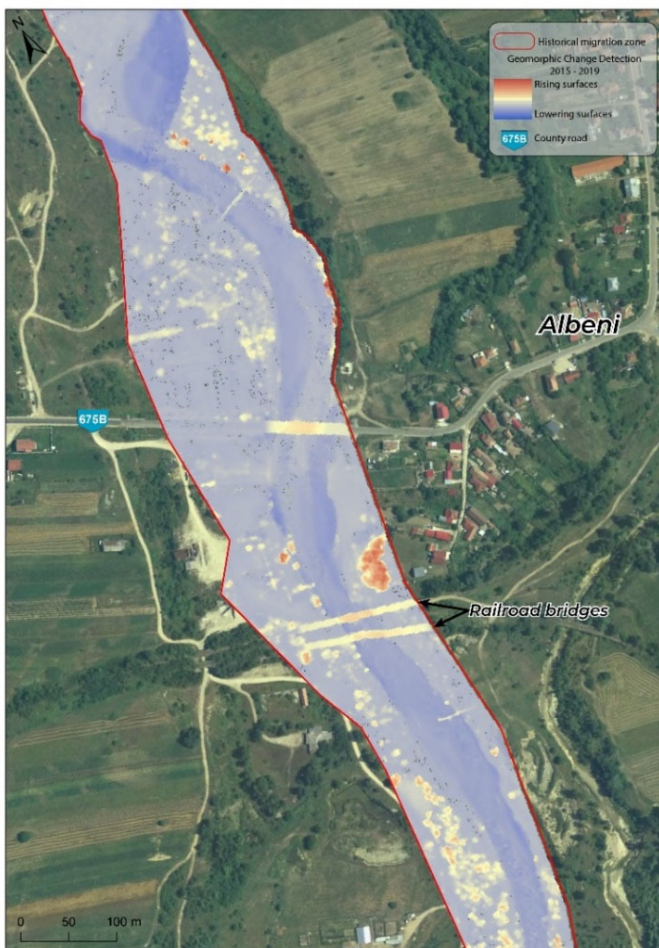
**Fig. 6.** GCD results at Albeni town bridges

In Albeni town, one bridge for the road infrastructure and two for the railway infrastructure were identified (Fig. 6).

The road bridge is both over the Gilort River and over a left tributary of it (Călnic), and the GCD results record a lowering of the topographic surface by up to  $-2.20$  m on the right bank of the Gilort and by up to 1 m on the left bank of Călnic. Also, downstream of the bridge, a sector with pronounced depth erosion is identified, with calculated values of lowering up to 4 m in the Gilort River bed and a sector with depth erosion with calculated lowering values of up to 3 m in the Călnic River bed. These sectors can destabilise the longitudinal profile of the river, leading to a natural process of balancing the profile by accentuating in-depth erosion upstream.

The two railway bridges located south of Albeni town (Fig. 6) belong to the same railway main (CF220 Cărbunești – Albeni – Călugăreasca), currently non-interoperable (according to National Railway Company data from 2020). Due to in-depth and lateral erosion, it became impossible to use, its structure and resistance being endangered by the lowering of the river's base level below the level of the bridge piers (Fig. 8). For the studied time interval, a lowering of the topographic surface by approximately 3 m was calculated, so erosion processes are still active in this area. The accentuated erosion tendency can also be observed in the cross-section, especially on the right bank of the Gilort (Fig. 9).
