## Change in the Chemical Composition and Strength of Wood that has been Used for a Long Time Under Water

**Abstract:** The article shows the importance of analyzing old wood strength properties in restoration and monitoring the structure's condition. The issue of the characteristics of wooden structures destruction in the salty water of the Gulf of Finland is discussed. In particular, wood's physical and mechanical properties are analyzed during the long-term operation in water. The result of testing of small standard samples for different types of stress states is shown. Changes in the chemical composition of wood are identified. The change in the chemical composition of the material affecting its strength properties is described on the example of Fort Kronschtot crib foundation. It has been established that the process of diffusion, amplified by alternating wave loads, led to the washing of extractive substances, a decrease in potassium, and a lack of calcium in the cell walls of tracheids. The results of this research work may be useful in assessing the residual life of long-term wooden structures underwater and in predicting the restoration time for these structures more accu

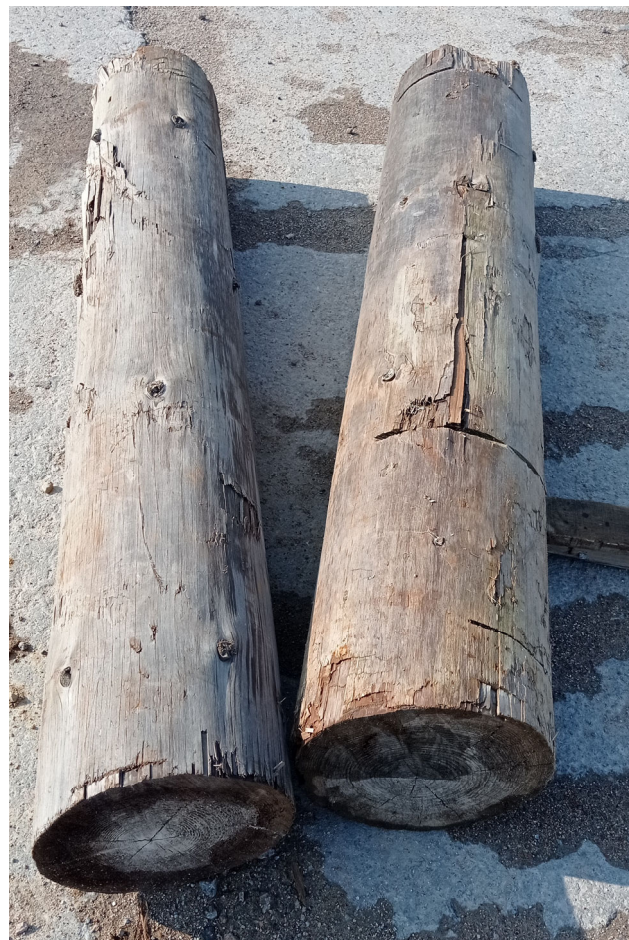
**Fig. 1.** Logs of the studied crib foundation

The diameter of the logs crib studied was 26 cm, length 1.5 m (Fig. 1). The material examination revealed that the log's central part (core) was light-colored and undamaged. The peripheral part (sapwood) had a bright dark grey color (Fig. 2). The outside part of the sapwood was full of radial cracks (fig. 3) at a depth of 0.5 to 2 cm. The area of the damaged part was 15 to 20% of the total cross-sectional area of the sample. The annual layers were 0.4 to 5.1 mm wide. The wood density was 370 kg/m<sup>3</sup>.

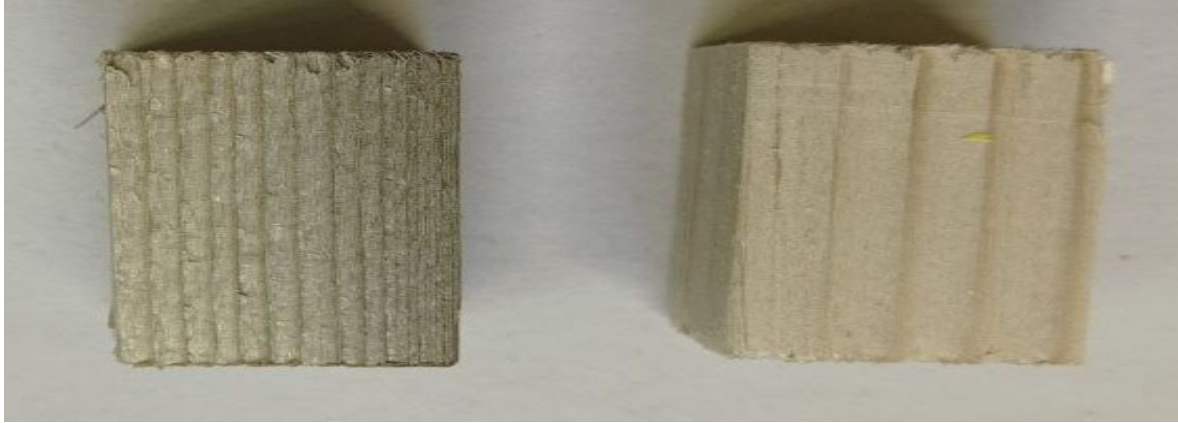
**Fig. 2.** Samples of light and dark grey wood of the studied log

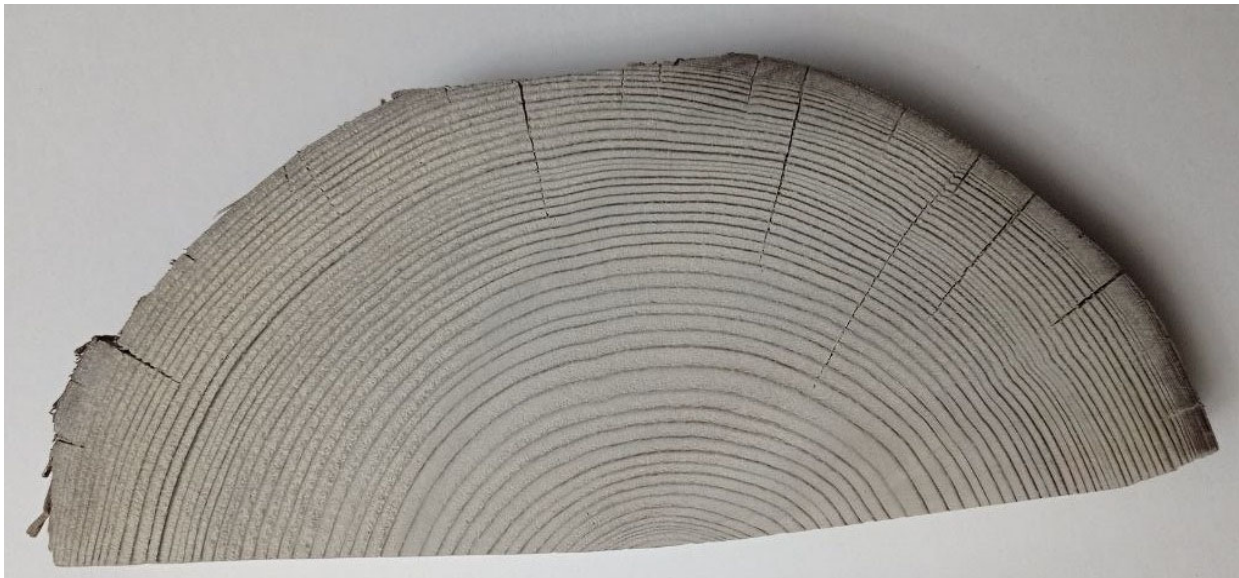
**Fig. 3.** Cracks of the peripheral part of the studied log
